INDOOR AIR QUALITY ASSESSMENT

**St. John the Evangelist Elementary School
111 New Baltch Street
Beverly, Massachusetts**

Prepared by:
Massachusetts Department of Public Health
Bureau of Environmental Health Assessment
August, 2001

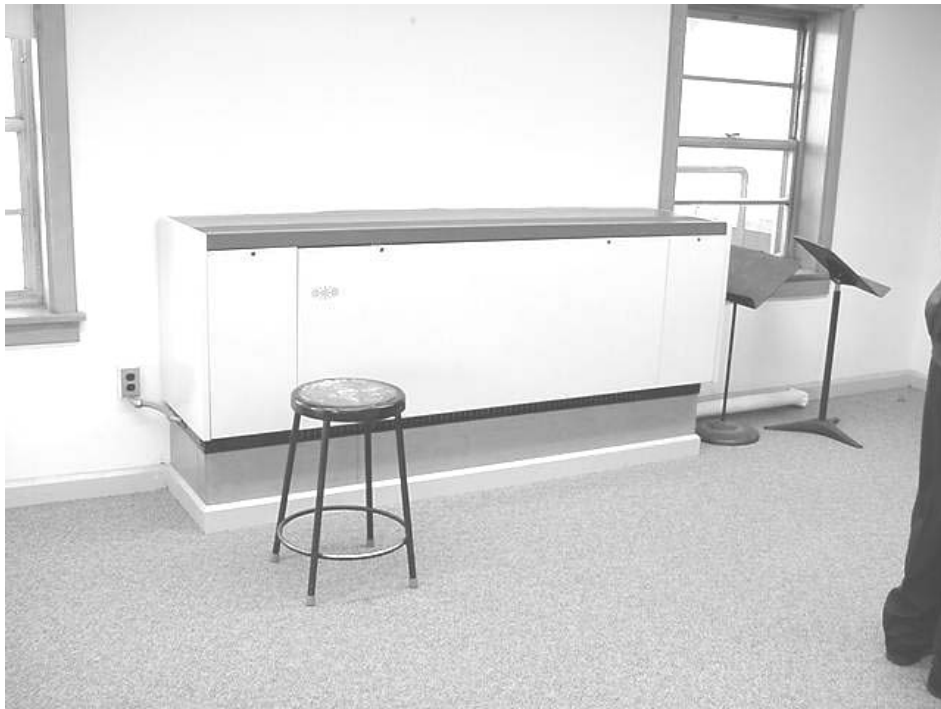
Picture 1

Fresh air in classrooms is supplied by a unit ventilator (univent) system (see Pictures 1 & 2). Univents draw air from outdoors through a fresh air intake located on the exterior walls of the building (see Picture 3) and return air through an air intake located at the base of each unit (see Figure 1). Fresh and return air are mixed, filtered, heated and provided to classrooms through a fresh air diffuser located in the top of the unit. Univents were found turned off in classrooms throughout the school. Obstructions to airflow, such as papers and books stored on univents and bookcases and carts and desks in front of univent returns were seen in a number of classrooms (see Picture 2). In order for univents to provide fresh air as designed, intakes must remain free of obstructions. Importantly these units must remain “on” and allowed to operate while these rooms are occupied.

Classroom Univent in Renovated Portion of Building

2. Examine each univent for function. Survey classrooms for univent function to ascertain if an adequate air supply exists for each room. Consider consulting a heating, ventilation and air conditioning (HVAC) engineer concerning the calibration of univent fresh air control dampers school-wide.

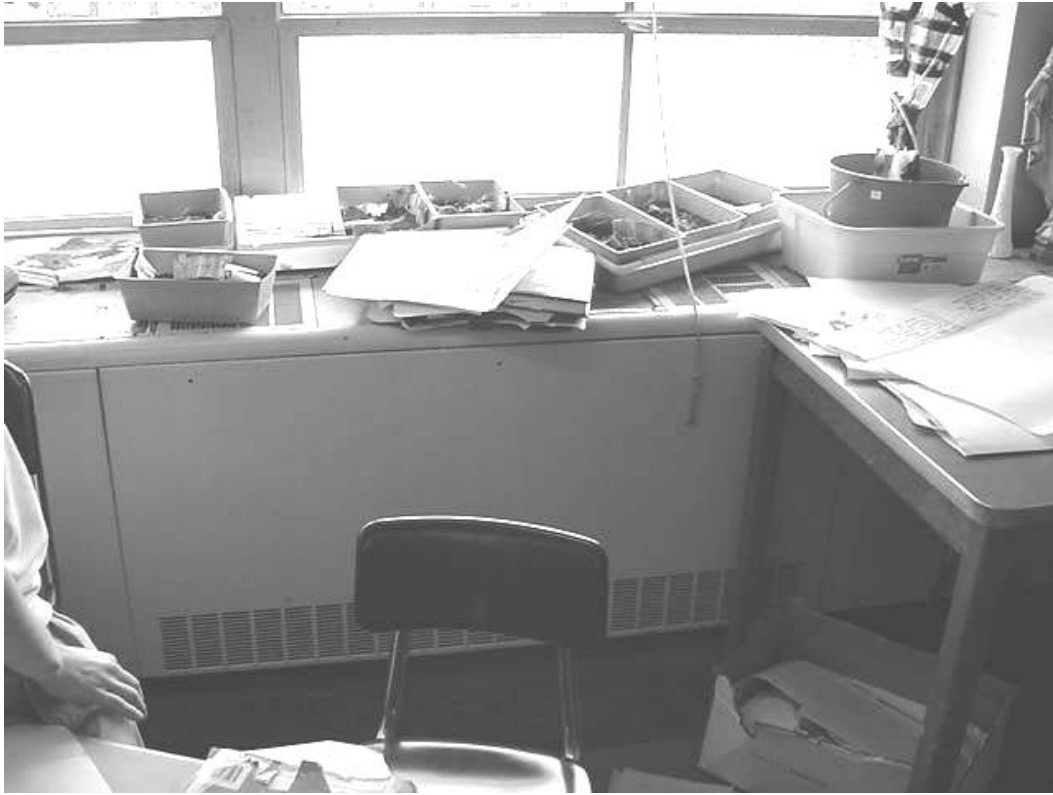
Picture 2

Classroom Univent in Original Portion of Building

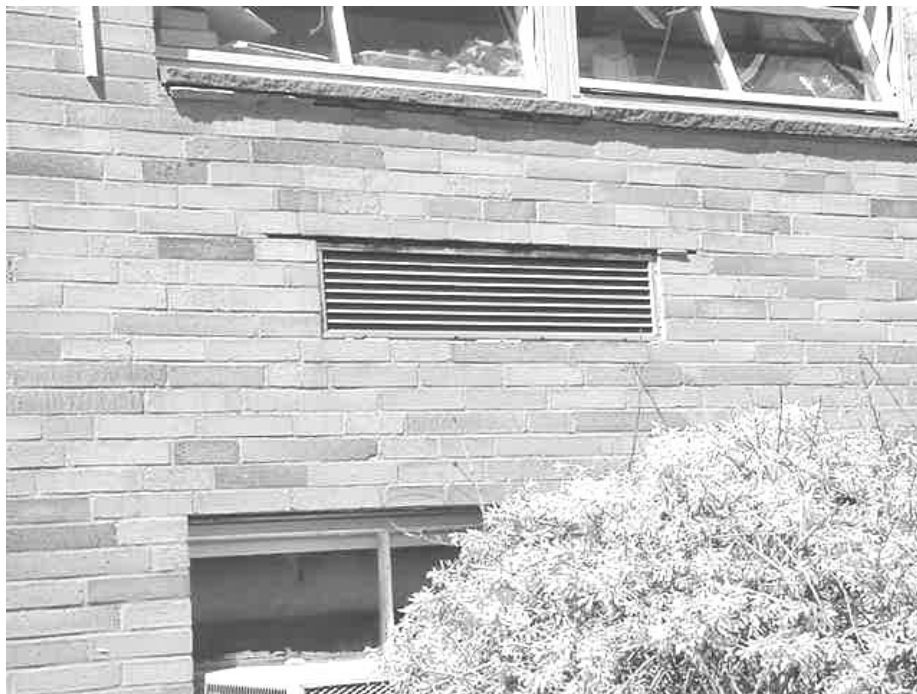
Picture 3

Univent Outside Air Intake

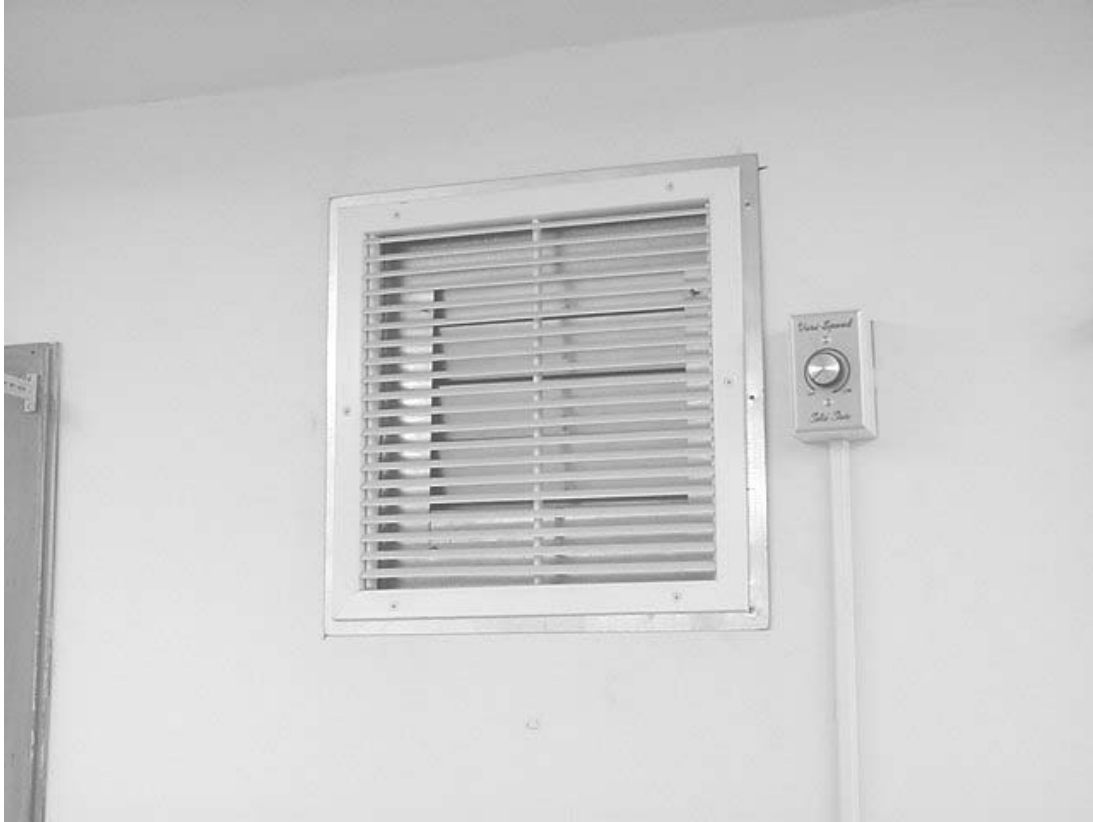
Picture 4

Mechanical exhaust ventilation for rooms in the renovated sections of the building (e.g., music room, library) is provided by wall-mounted local exhaust vents controlled by a manual variable speed dial (see Pictures 4 & 5). Mechanical exhaust ventilation for the remainder of the classrooms in the building is provided by wall-mounted intake grills located in coat closets (see Picture 6) powered by rooftop motors (see Picture 7). A number of exhaust vents in both the original and renovated sections of the building were deactivated. BEHA staff examined exhaust motors on the roof and found a number of exhaust motors not operating. Exhaust motors and casings appeared to be original equipment (approximately 40-50 years old) and were corroded, weathered and/or physically damaged (see Pictures 8 & 9). Exhaust vents in the original building have internal flues that are controlled by pull chains to adjust airflow. A few of these vents

Wall-Mounted Local Exhaust Vent with Variable Speed Control

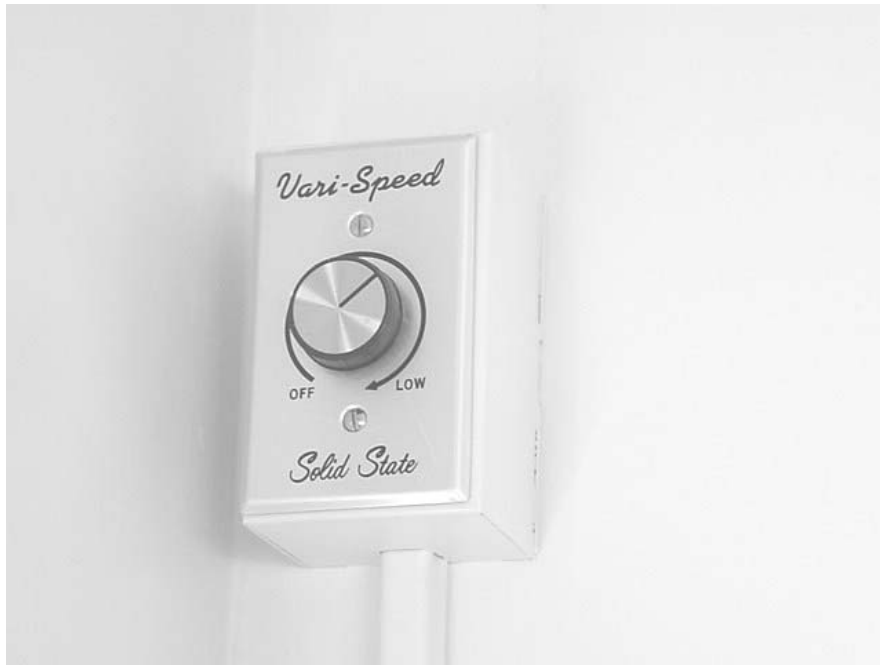
Picture 5

Close-up of Variable Speed Control for Local Exhaust Vent (see Preceding Picture)

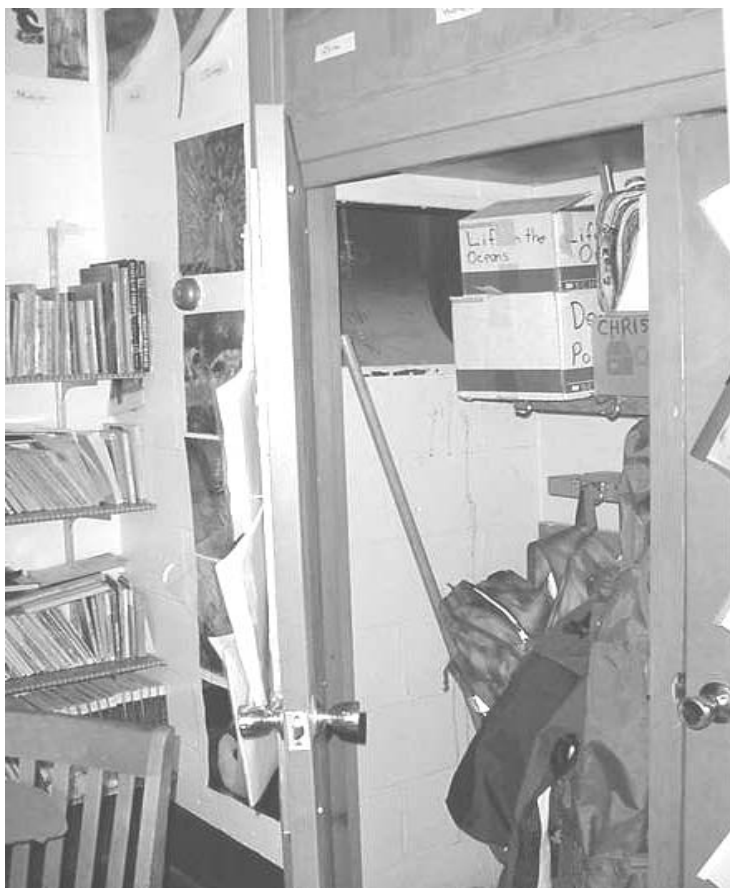
Picture 6

had pull chains missing. As with the univents, a number of exhaust vents were obstructed by various items stored in the coat closets.

Classroom Exhaust Vent in Coat Closet

4. Remove all blockages from univents and exhaust vents.
5. Once both the fresh air supply and exhaust ventilation are functioning, the ventilation system should be balanced.

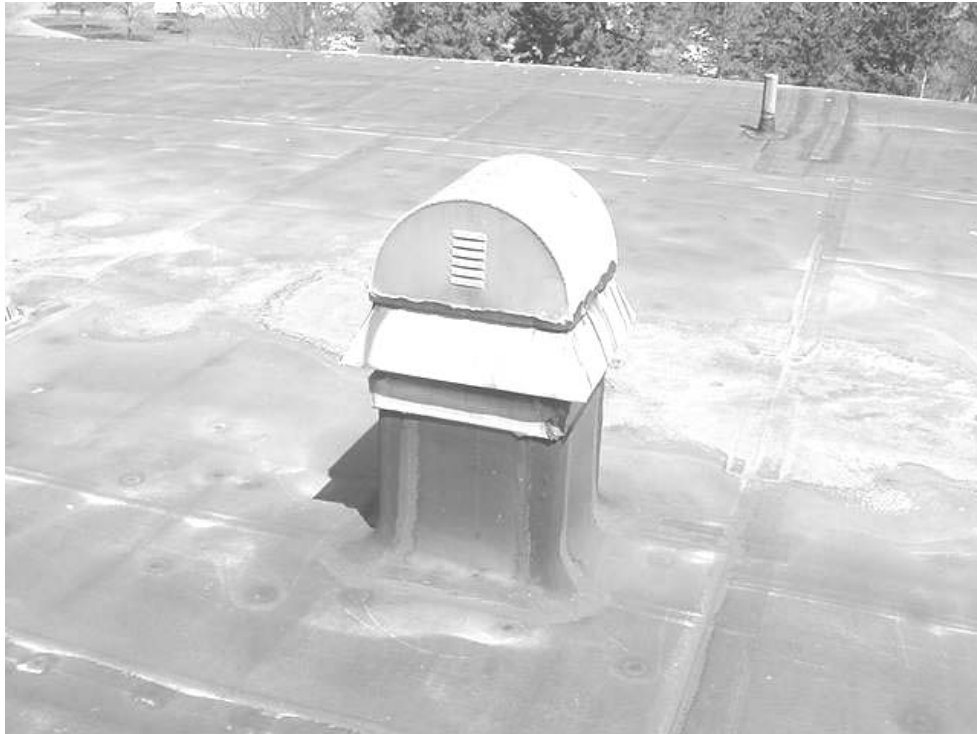
Picture 7

Rooftop Exhaust Motor

3. Restore exhaust ventilation in classrooms and restrooms. Inspect exhaust motors and belts for proper function, repair and replace as necessary. Ensure flues are open and pull chains for closet exhaust vents in the old wing are operable.

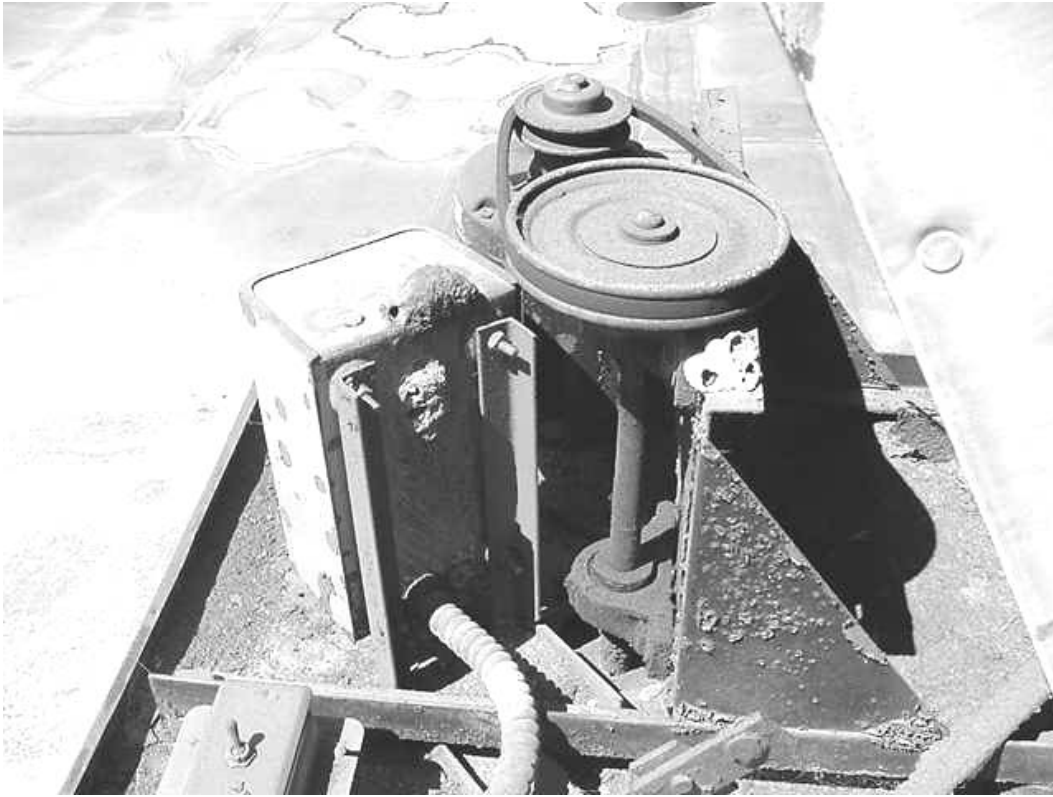
Picture 8

**Interior of Exhaust Motor Note Corrosion as Indicated by Rust
and Accumulations of Metal Chips and Debris**

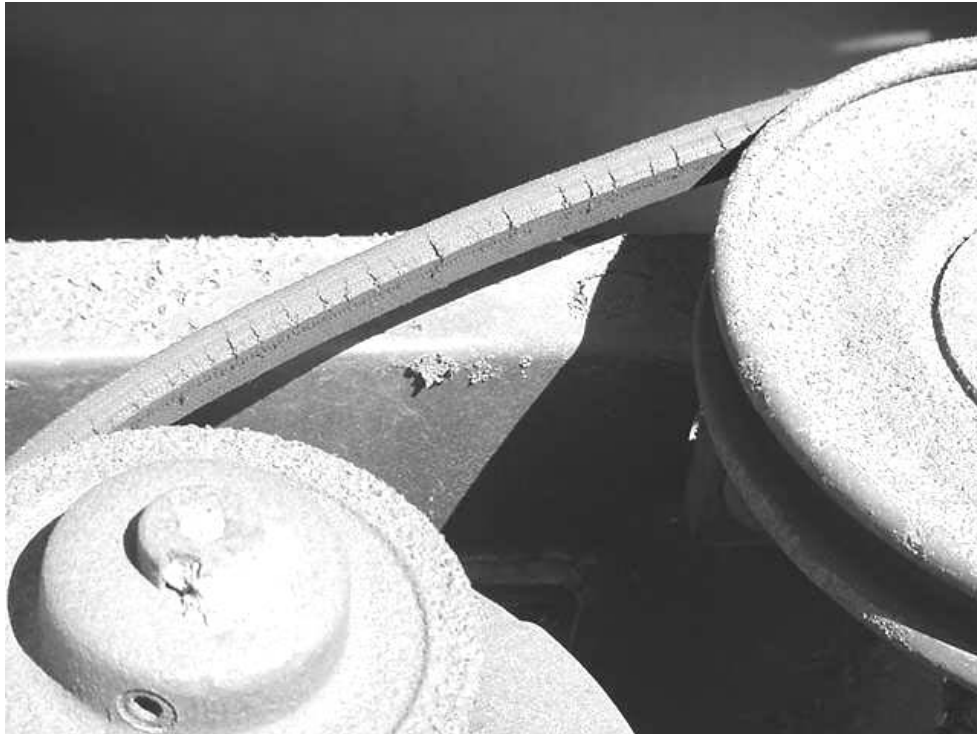
Picture 9

Close-up of Dry/Cracked Fan Belt of Rooftop Exhaust Motor

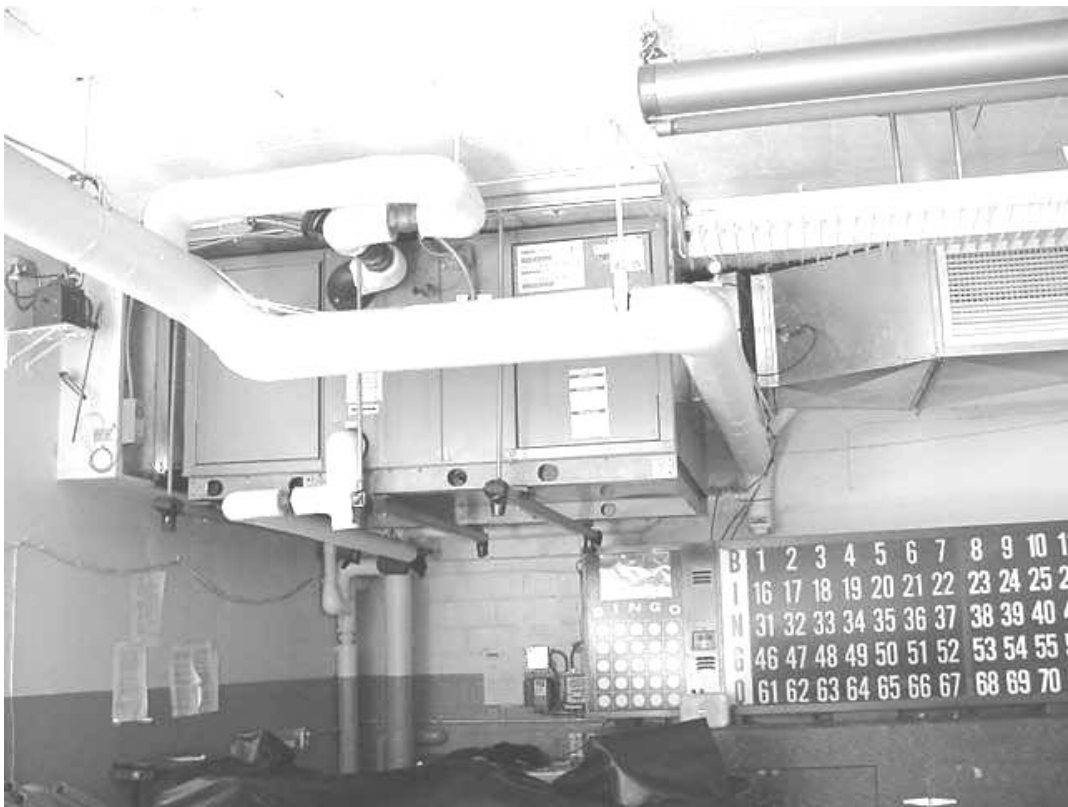
Picture 10

Ventilation for the cafeteria is provided by a ceiling-mounted air-handling unit (AHU) (see Picture 10). Fresh air is introduced into the unit through an air intake on the exterior of the building and distributed into the cafeteria via air diffusers connected to ductwork. Like many of the univents, the AHU was not operating during the assessment.

Ceiling-Mounted AHU in Cafeteria

1. To maximize air exchange, the BEHA recommends that both supply and exhaust ventilation operate continuously during periods of school occupancy independent of classroom thermostat control.

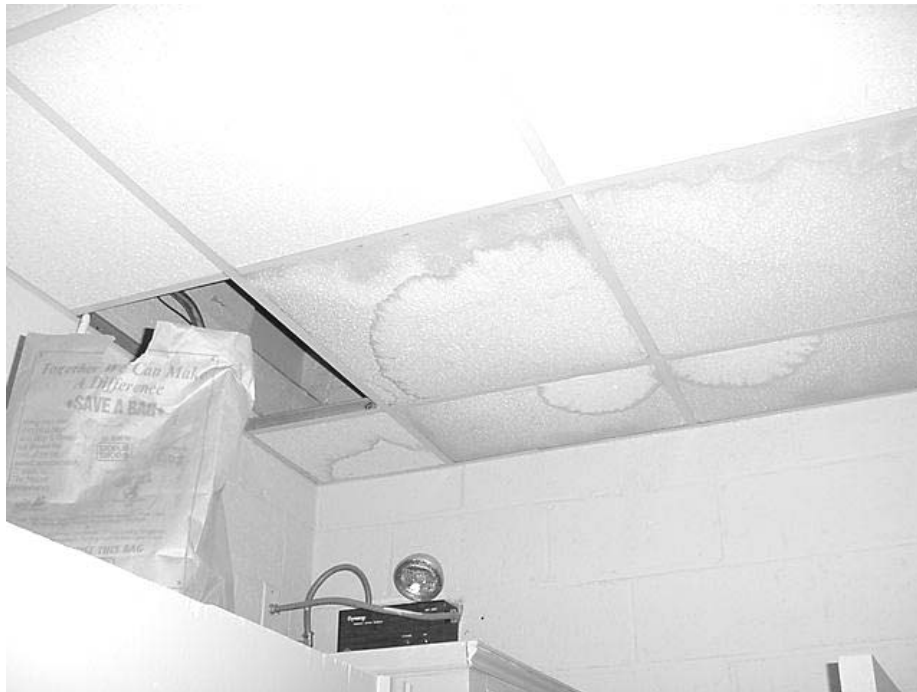
Picture 11

A few areas had water-damaged ceiling tiles which can indicate leaks from either the roof or plumbing system (see Pictures 11 & 12). An active leak was reported in the church, which resulted from a recent period of heavy precipitation. School officials reported that they have been working with a roofing contractor to try to isolate and repair the leak. Water-damaged ceiling tiles and other porous building materials can provide a source of microbial growth and should be repaired/replaced after a water leak is discovered.

Water Damaged Ceiling Tiles

7. Continue to work with roofing contractor to identify and repair leaks.

Replace/repair any remaining water-stained ceiling tiles and building materials.

Examine the area above and around these areas for microbial growth. Disinfect areas of water leaks with an appropriate antimicrobial.

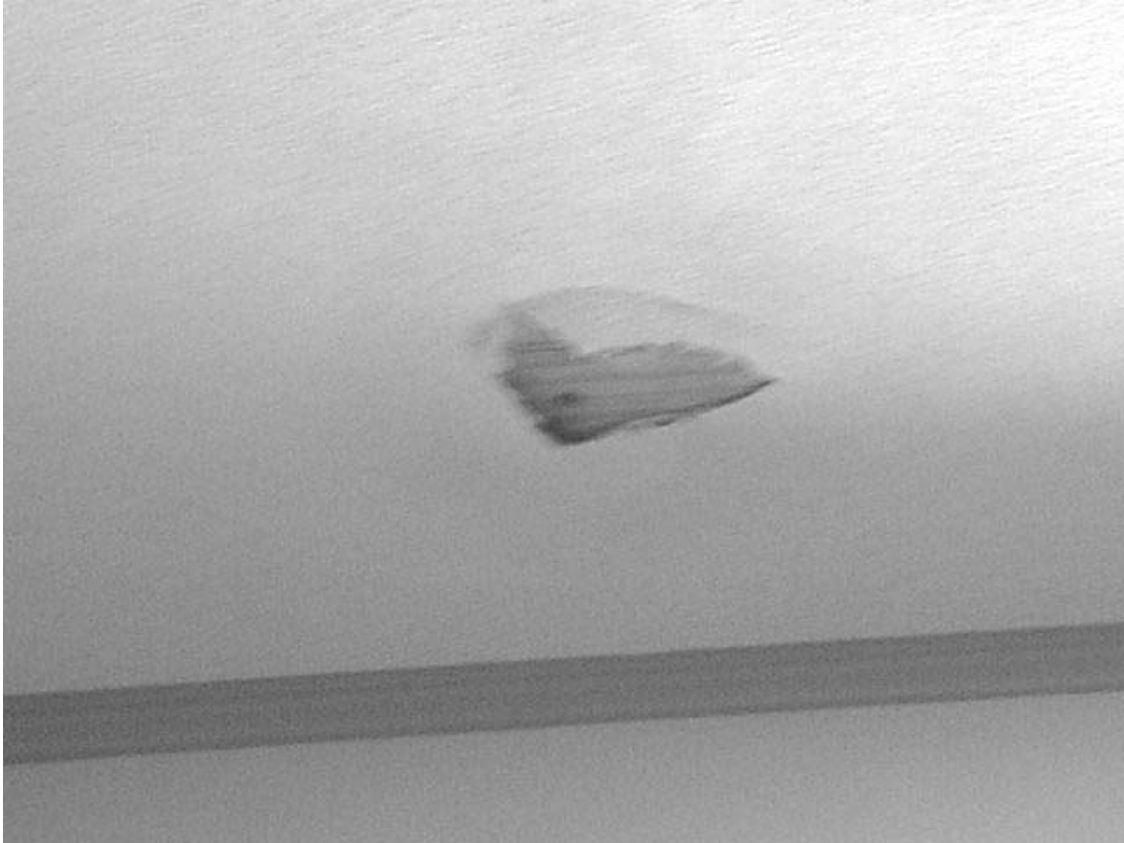
Picture 12

Water Damaged Ceiling Plaster in Church

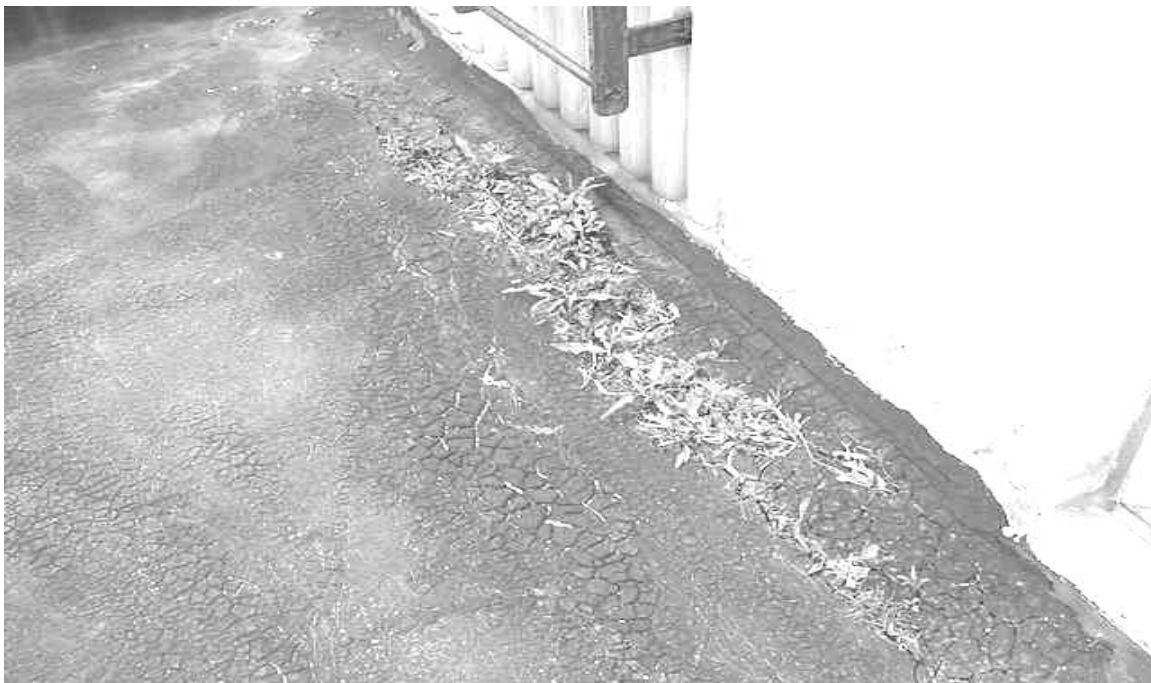
Picture 13

Plants were seen growing in fissures in the rubber membrane roof outside of the library (see Picture 13). Plants can cause damage to building materials by inserting tendrils into these cracks and fissures. As water penetrates along the tendrils, subsequent freezing and thawing during the winter can create further damage.

These breaches of the building envelope can serve as a source of water entry into the building, causing water damage and potentially leading to microbial growth.

Plant Growth in Cracks of Rubber Membrane Roof

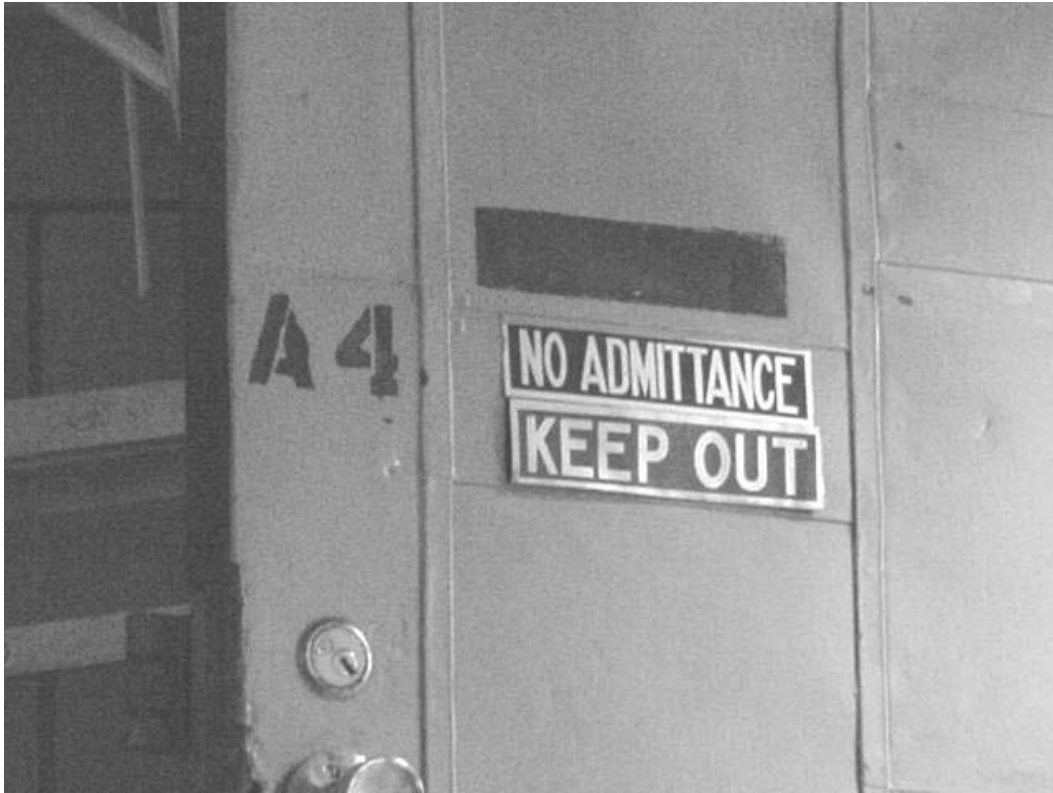
Picture 14

Several conditions that can potentially affect indoor air quality were also identified. During the assessment boiler room doors were found open (see Picture 14) and school staff were observed using the boiler room as a pathway from the rear of the building to the cafeteria. Leaving these doors open can serve as a means of egress for heat, particles and fuel odors from the boiler room into adjacent areas (e.g., the cafeteria).

Opened Boiler Room Door

11. Clean chalkboards and trays regularly to avoid the build-up of excessive chalk dust.
12. Keep boiler room doors closed and prevent access to building occupants.

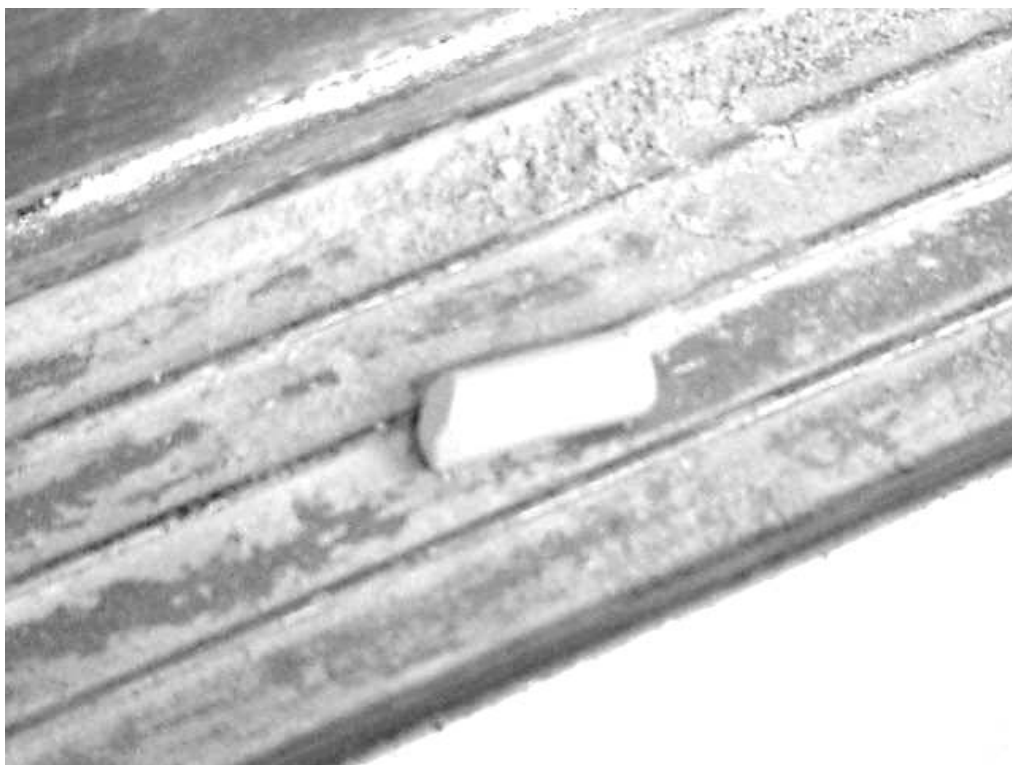
Picture 15

Accumulated chalk dust was noted in several classrooms (see Picture 15). Chalk dust is a fine particulate, which can be easily aerosolized and is an eye and respiratory irritant. Several classrooms contained dry erase boards and dry erase markers. Materials such as dry erase markers and dry erase board cleaners may contain volatile organic compounds (VOCs), (e.g., methyl isobutyl ketone, n-butyl acetate and butyl-cellusolve) (Sanford, 1999), which can be irritating to the eyes, nose and throat.

Accumulated Chalk Dust in Classroom

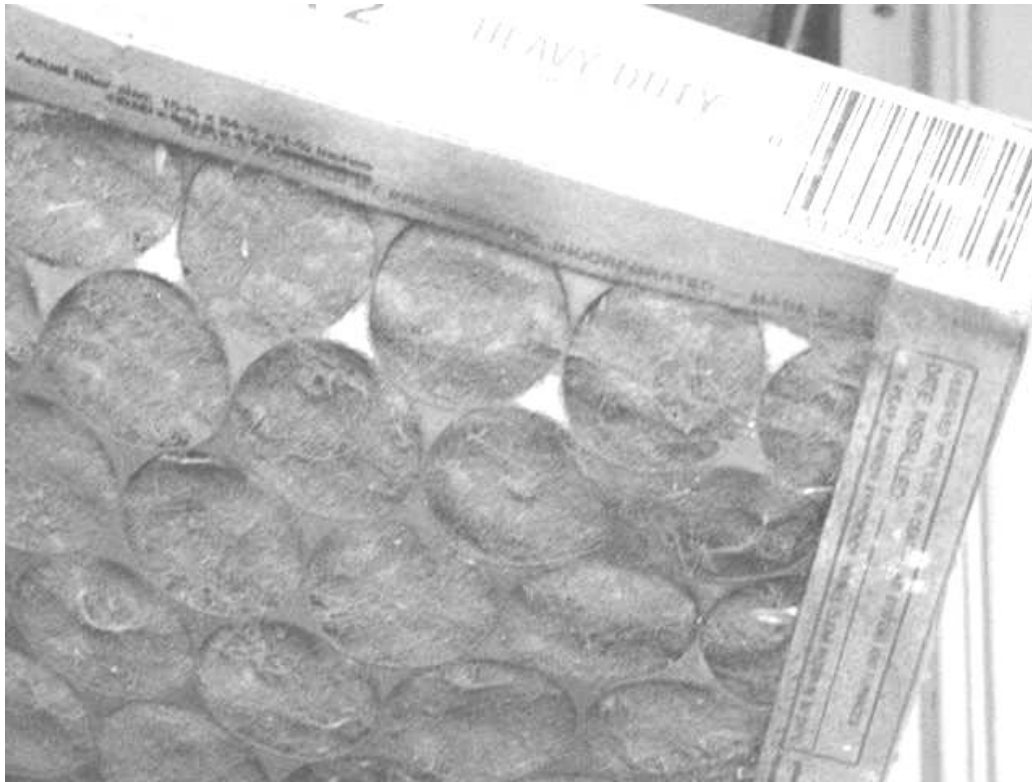
Picture 16

BEHA staff examined the cafeteria AHU and found the filter coated with dirt/dust and accumulated material (see Picture 16). A debris-saturated filter can obstruct airflow, damage equipment and may serve as a reservoir of particulates that can be re-aerosolized and distributed throughout the cafeteria via the ventilation system. Several areas contained window-mounted air conditioners. These units are also equipped with filters, which should be cleaned or changed as per the manufacturer's instructions to avoid the build up and re-aerosolization of dirt, dust and particulate matter.

Cafeteria AHU Saturated With Dirt, Dust & Debris

13. Change/clean filters in the cafeteria AHU, univents and wall-mounted air conditioners as per the manufacturer's instructions (or more frequently if needed) to prevent the re-aerosolization of dirt, dust and particulate matter.

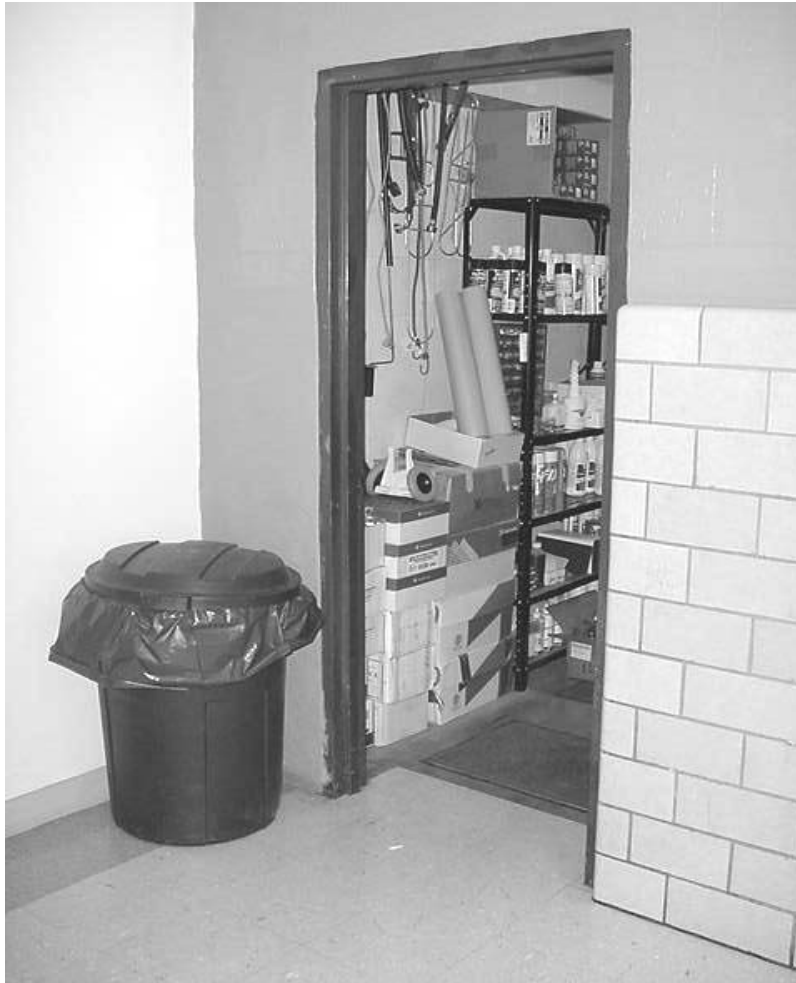
Picture 17

Cleaning products were found on countertops and underneath sinks in a number of classrooms. Storage room C2 contained a number of supplies including hydrochloric acid and a number of flammable materials (see Pictures 17 & 18). This area was found open during the assessment, allowing easy student access. Cleaning products and

flammables contain chemicals, which can be irritating to the eyes, nose and throat. These materials should be stored properly and kept out of reach of students.

Open Storeroom/Janitorial Closet

9. Store cleaning products properly and out of reach of students. Store flammables in a flameproof cabinet. Keep custodial/supply rooms locked at all times.

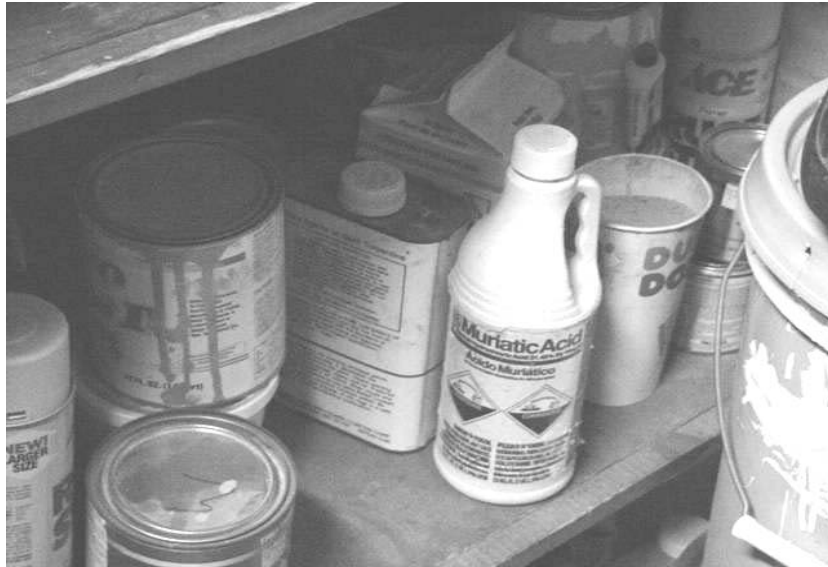
Picture 18

Cleaning Supplies & Chemicals Found in Open Storeroom
